AVON LOCAL SCHOOLS FACILITY ASSESSMENTS

October 31, 2023

Executive Summary

FACILITY ASSESSMENT REPORT

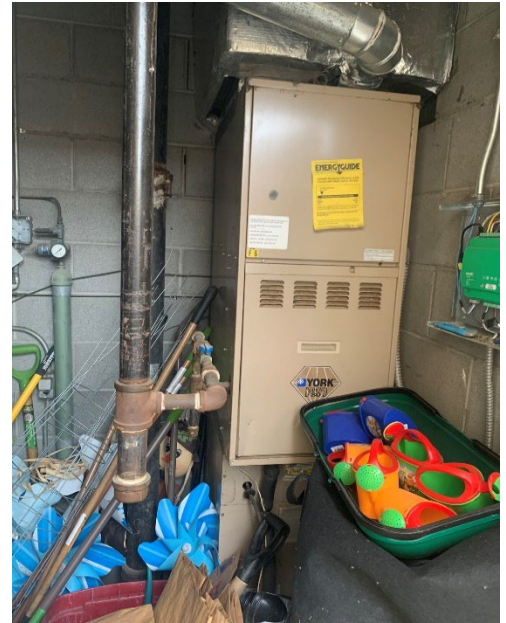
It appears that the furnace/AC units are about 20+ years old with the remaining rooftop single zone and multi-zone units being installed when the addition occurred. Typical life expectancy of RTU's is 15-20 years.

Classroom Furnace/AC Unit

Provide overall new heating systems including air conditioning in all areas. The new systems will have central heating and cooling systems to eliminate all the single zone equipment. Separate control for each space will be provided along with adequate outside air ventilation.

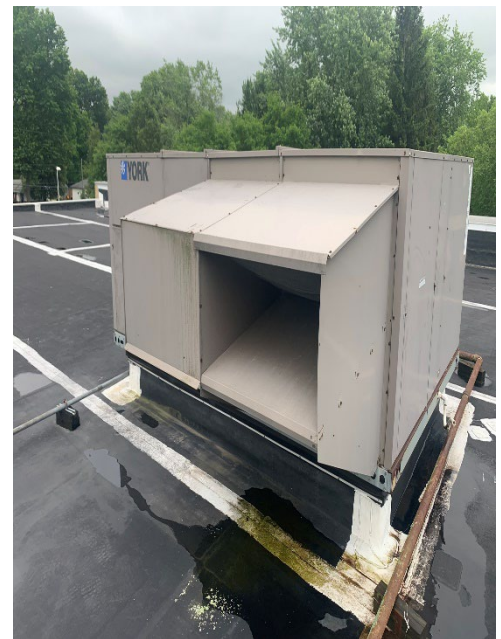
Single Zone RTU

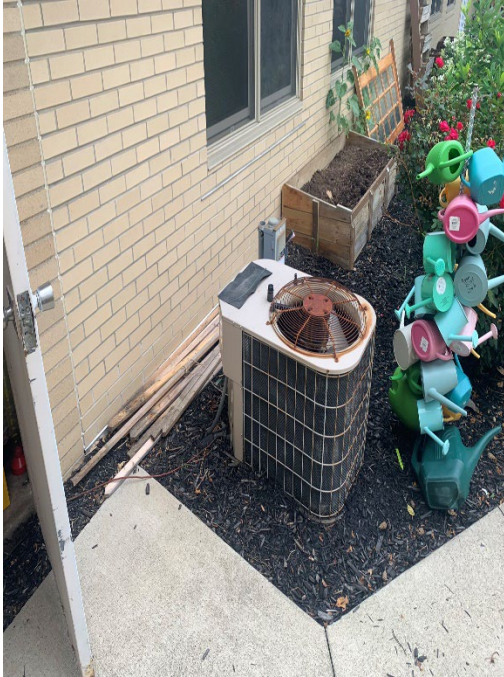
Furnace/AC Condensing Unit

Upgrade the entire heating and air conditioning system as noted in Item A. All costs are covered in that section.

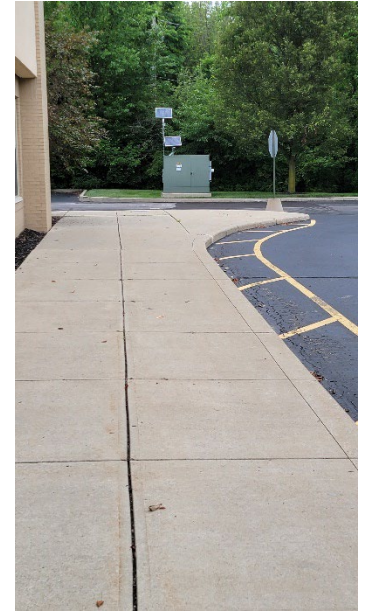
Power is provided to the school by a single utility owned, pad-mounted transformer located outside the building, and in good condition. The panel system, installed in 2003 on the mezzanine in the Maintenance Room, is in good condition, and can be expanded to add additional capacity.

Pad Mounted Transformer

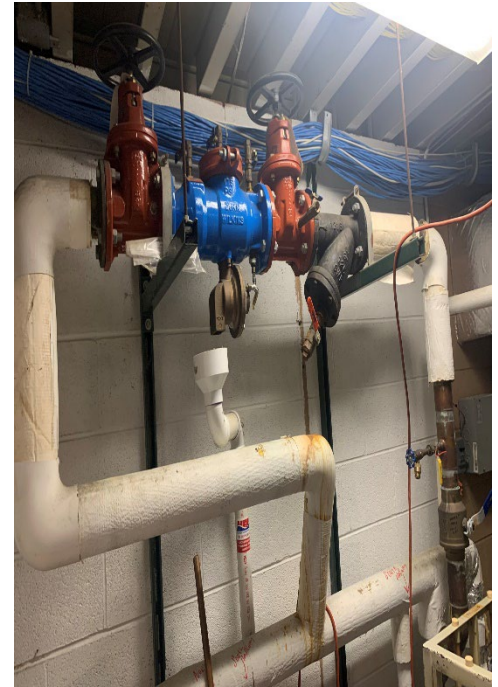
The incoming water service for the entire facility is a 4" line with the required backflow preventer. The overall facility has 3 gas-fired domestic water heaters. Two are only 4 years old and one is 13 years old. This one should be replaced due to the age.

Water Service Backflow Preventer

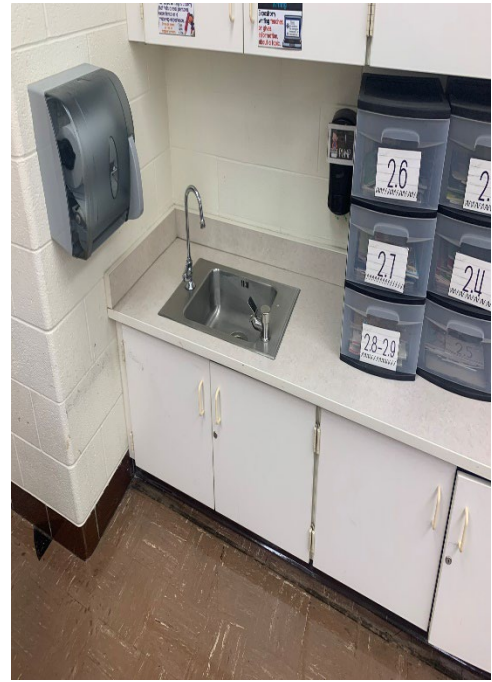
Classroom Sink with Water Fountain

- Remove/Replace 1 domestic hot water heater.
- Remove/Replace 26 water closets.
- Remove/Replace 11 urinals.
- Remove/Replace 26 lavatories.
- Remove/Replace 3 electric water coolers.
- Add a grease trap to the kitchen sanitary system.

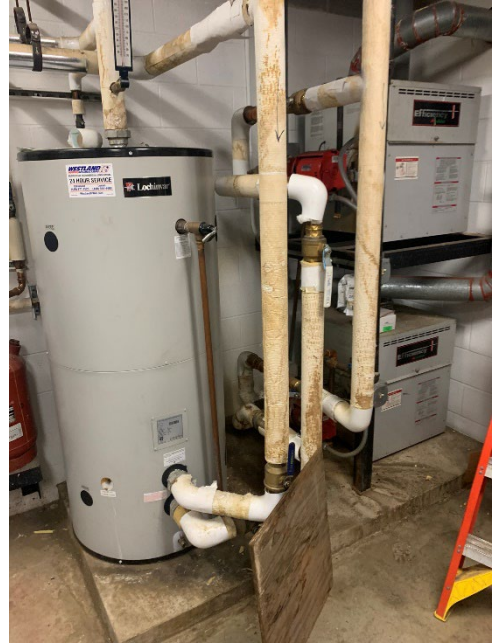
Gas fired domestic water heater and storage tank.

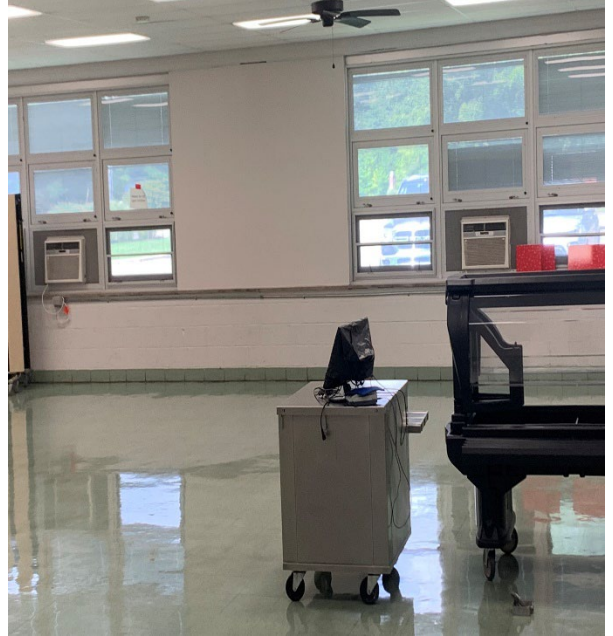
Window A/C Unit

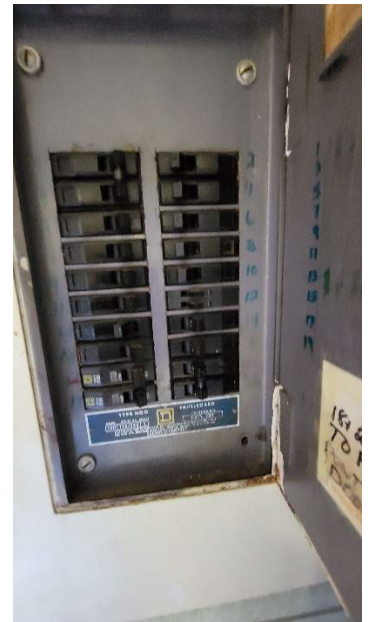
Typical Panel in Original Construction

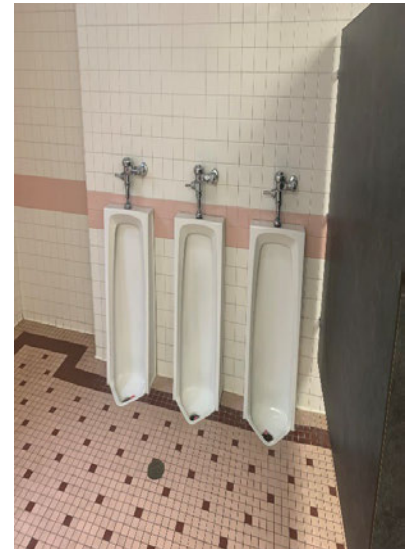
Floor-Mounted Urinals with Manual Flush Valves

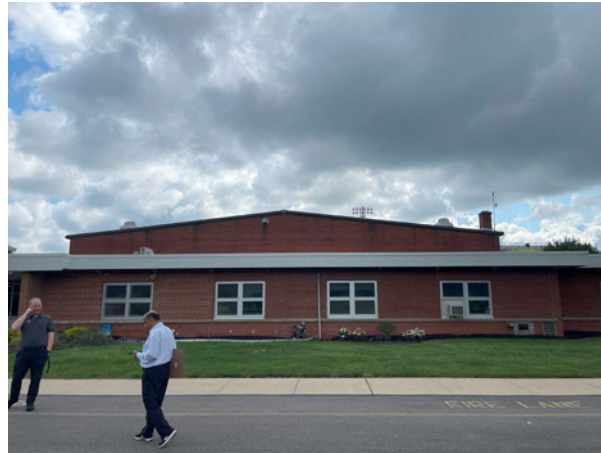
The overall facility has a brick veneer on load bearing masonry wall system, which displayed some locations of deterioration, and is in fair condition. The exterior masonry appears to have appropriately spaced and adequately caulked control joints in fair condition. Control joints are provided at lintel locations, at doors and windows, building corners, and wall offsets. The school does have sufficient expansion joints, and they are in fair condition.

Exterior Wall

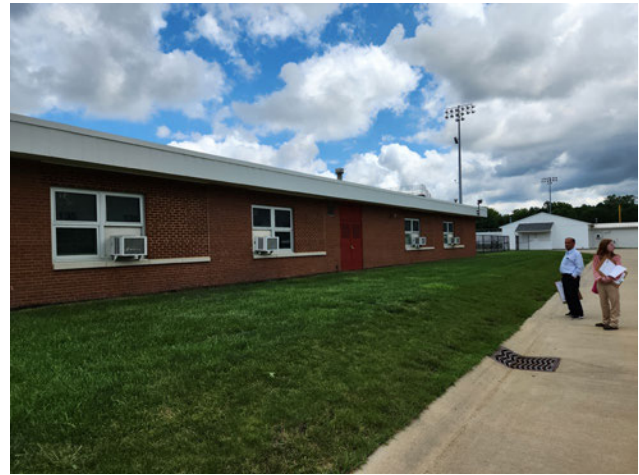
The exterior masonry has been cleaned and sealed in recent years, showing minimal evidence of mortar deterioration.

Exterior Brick and Control Joints

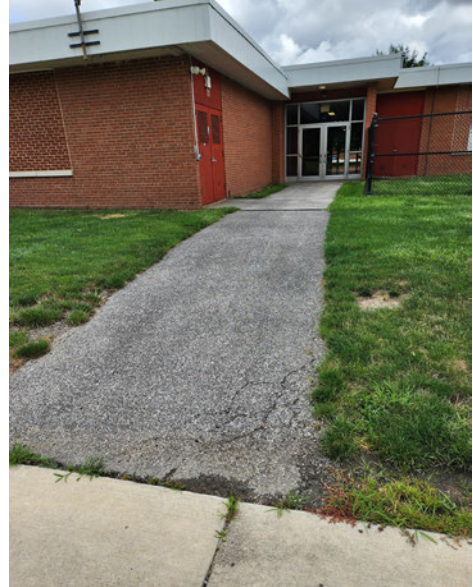
Cracked Walkway

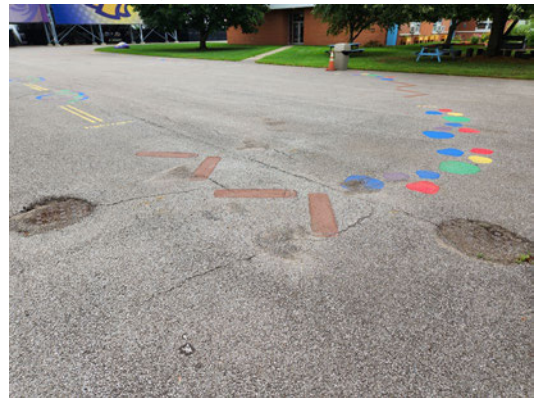
Cracked Playground Surface

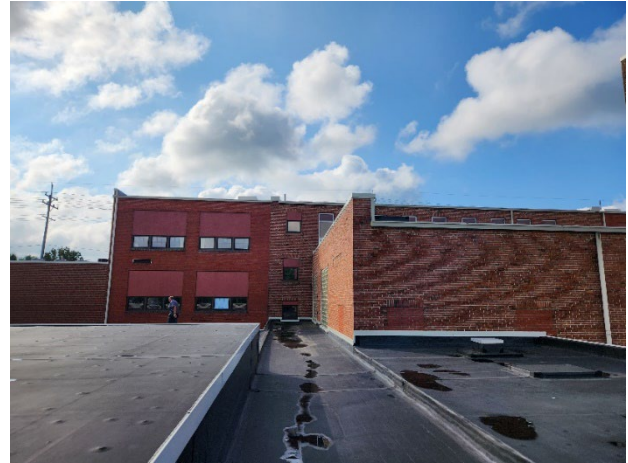
The roof over the overall facility is an EPDM system that was installed in 2005, and is in poor condition. There are District reports of current leaking. The assessment was conducted the day after a large rain event and new leaking was witnessed in the south east area of the 1929 addition. The leaking was so severe that ceiling tiles were so inundated by water that they fell from the grid to the floor. Signs of past leaking were observed during the physical assessment. Access to the roof was gained by portable ladder to the side of the building. Other roof levels were not easily accessible.

Roof

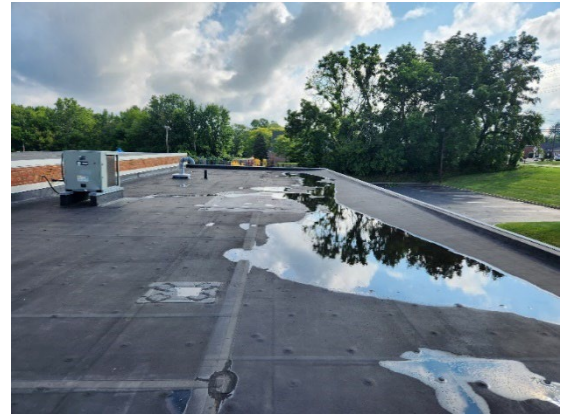
There were observations of standing water on the roof. Metal cap flashings and stone copings are in fair condition but will need replaced as the roof is replaced. Roof storm drainage is addressed through a system of gutters and downspouts and roof drains, which are properly located, and in poor condition. Canopies over entrances do not have any manner of drainage which results in water pooling up and overflowing to the ground below, creating wash-out. The roof is not equipped with overflow roof drains though they will be required in areas of roof replacement.

Standing water on Roof

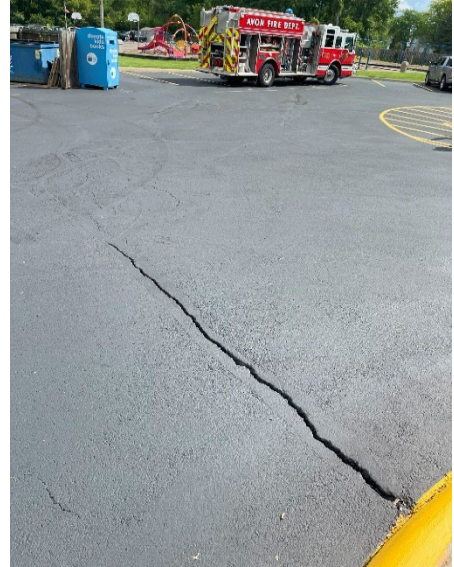
Cracks in Parking Lot
