AVON LOCAL SCHOOLS FACILITY ASSESSMENTS

October 31, 2023

Executive Summary

FACILITY ASSESSMENT REPORT

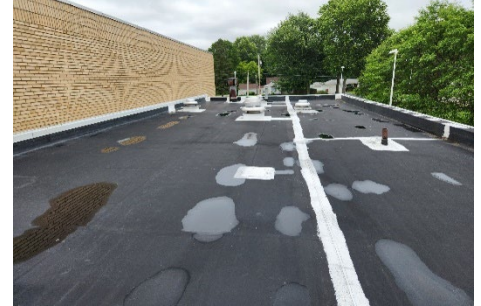
Existing Roof

The roof over the overall facility is an EPDM system that was installed in 2000, and is in poor condition. There are no District reports of current leaking. No signs of past leaking were observed during the physical assessment. Access to the roof was gained by access hatch that is in fair to poor condition, as well as access door that is in fair condition. Fall safety protection cages are not required and are not provided.

There were observations of standing water on the roof. Metal cap flashings and stone copings are in fair condition. Roof storm drainage is addressed through a system of roof drains, which are properly located, and in poor condition. The roof over much of the building is not equipped with overflow roof drains though they will be required in areas of roof replacement. The 2003 gymnasium addition, and 2004 addition contain overflow drains.

The roof over the overall facility requires replacement to meet Ohio School Design Manual guidelines due to age of the system. Due to the roof replacement, roof drains require replacement and overflow drains will be required to be added. Coping and flashing should be replaced as well due to roof replacement. Roof ladders should be replaced due to condition, as well as the access hatch. Gutters should be added to covering at the entrance.

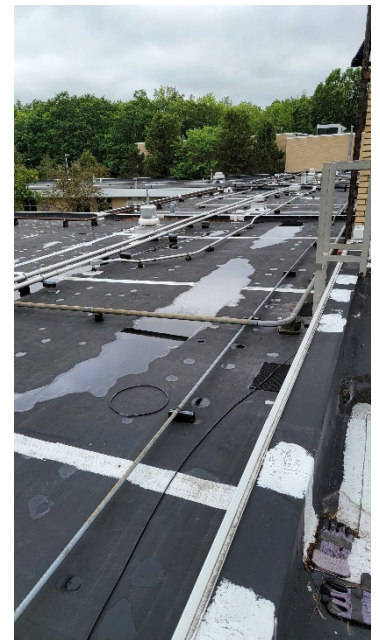
Electrical Feeder Conduits on Roof

The electrical system provided to the overall facility is a 480 Volt, 1200 Amp, 3 phase, 4 wire system installed in the 2003 addition, and is in good condition. The system back feeds the panels in the original construction and additions utilizing conduits mounted above the roof.

Remove and replace electrical feeders on roof due to roof replacement.
 Provide adequate lightning protection safeguards.
 Provide cost for electrical generator.

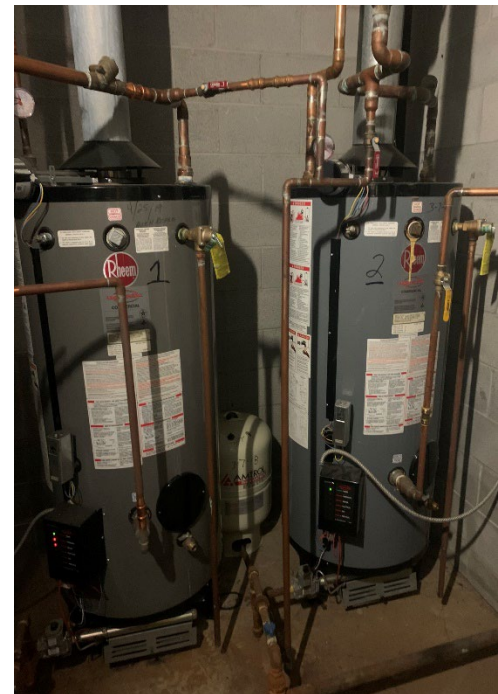
Gas-fired Domestic Water Heater

The incoming water service for the entire facility is a 4" line with the required backflow preventer. The overall facility has 3 gas-fired domestic water heaters. Two are only 4 years old and one is 13 years old. This one should be replaced due to the age.

- Remove/Replace 1 domestic hot water heater.
- Remove/Replace 26 water closets.
- Remove/Replace 11 urinals.
- Remove/Replace 26 lavatories.
- Remove/Replace 3 electric water coolers.
- Add a grease trap to the kitchen sanitary system.

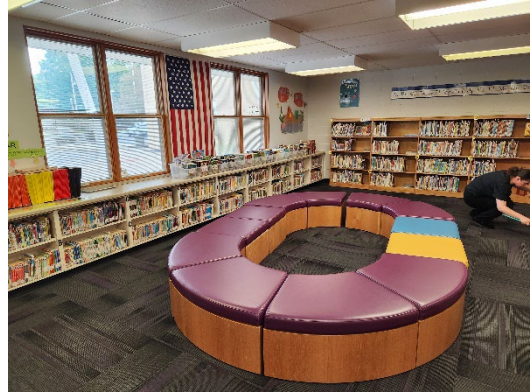
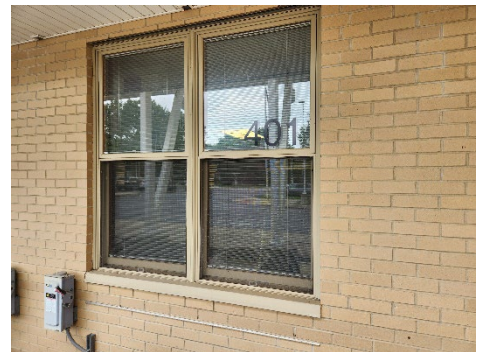
The 1970 Addition is equipped with aluminum frame windows with single glazed type window system, which is original to the addition, and is in poor condition. The 2004 addition has aluminum clad wood windows which are in fair to poor condition. The remainder of the facility has aluminum frame windows with double glazed insulated type window system in fair condition. The window system features operable windows throughout the building, and operable windows are not equipped with opening limiters. Windows feature sashes that do not stay open and therefore are hazardous to users. Window system seals are in fair condition, with minimal air and water infiltration being experienced. Window system hardware is in fair to poor condition. The window system features surface mounted blinds in the 1970 Addition and integral blinds in the remainder of the building, which are in fair condition.

Provide a new insulated window system with integral blinds due to existing window conditions.

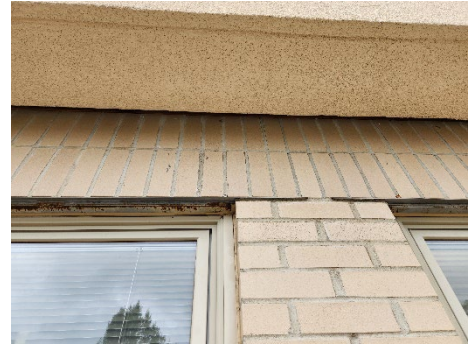
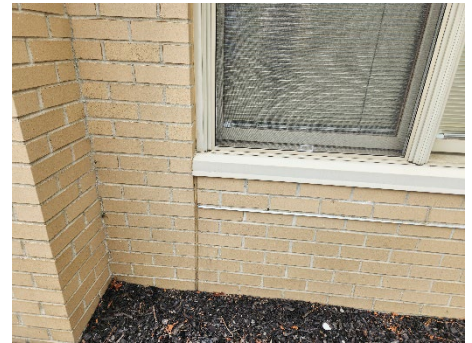
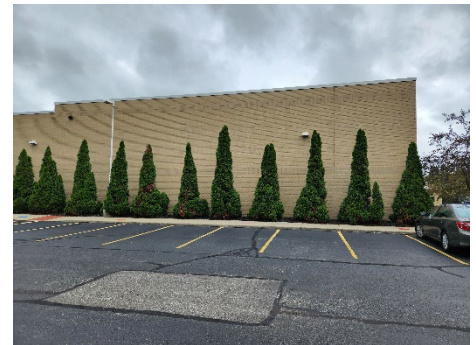
Weep holes are not provided at all lintels, below sills, and the base of masonry cavity walls, and are in poor condition. Weep holes are rope type weeps. Vents are not provided.

The exterior masonry has been cleaned and sealed in recent years, showing no evidence of mortar deterioration. Architectural exterior accent materials consist of EIFS, which is in poor condition.

The window sills are concrete, and are in fair condition. The exterior lintels are steel, and are in fair condition, but are not sealed or painted. The chimney is in fair condition, but would require tuckpointing, cleaning, and sealing. Chimneys will not be needed with the new HVAC system proposed in Item A and therefore should be removed. Canopies over entrances are metal panel and Kalwall and are in fair condition. Exterior soffits are of metal panel type construction, and in fair condition.

Provide tuckpointing in all areas of mortar deterioration as required through the overall facility. Provide masonry cleaning, sealing, and caulking as required through the overall facility. Prep and paint exposed steel lintels through the overall facility. Provide for demolition of chimneys.

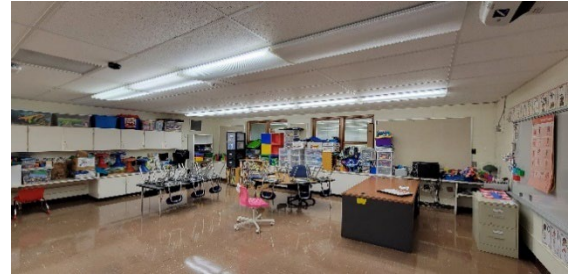
Typical Classroom Lighting

The typical Classrooms in the overall facility are equipped with T-8 2x4 surface mount fluorescent fixtures with dual level switching. Classroom fixtures are in good condition, providing an average illumination of 65 FC, thus complying with the 50 FC recommended by the OSDM.

Provide complete replacement of lighting system due to installation of systems outlined in Items A and U.

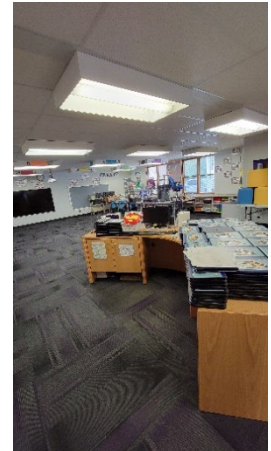
Media Center Lighting

The Media Center is equipped with 2x4 surface mount T-8 fluorescent fixture type lighting in good condition, providing an average illumination of 11 FC, which is less than the 50 FC recommended by the OSDM.

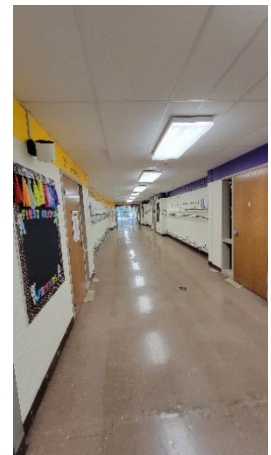
Typical Corridor Lighting

The typical Corridors in the overall facility are equipped with T-8 2x4 surface mount fluorescent fixtures with dual level switching. Corridor fixtures are in good condition, providing an average illumination of 23 FC, thus complying with the 20 FC recommended by the OSDM.

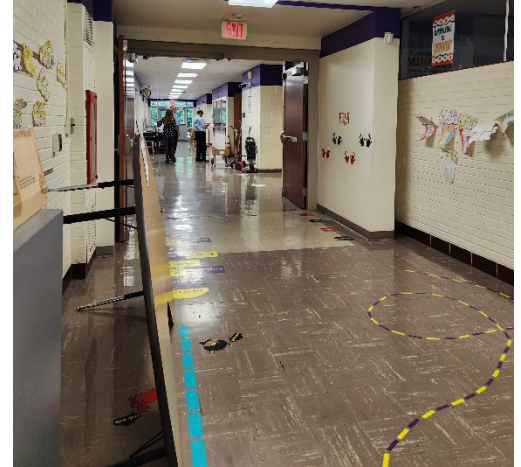
The overall facility is equipped with an emergency egress lighting system consisting of non-compliant red-lettered, plastic construction exit signs, and the system is in good condition. The facility is not equipped with emergency egress floodlighting, but is equipped with fluorescent lighting used as emergency egress lighting, and the system is in good condition. The system is provided with appropriate battery backup.

Emergency lighting will be replaced due to the replacement of fixtures in Item K.

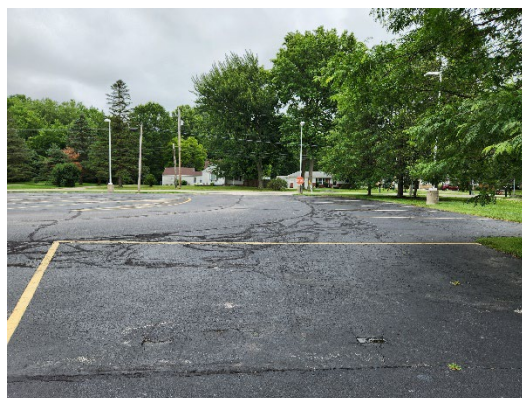
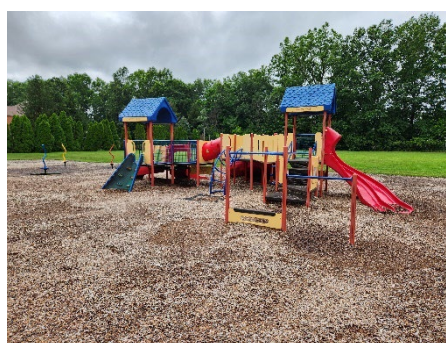
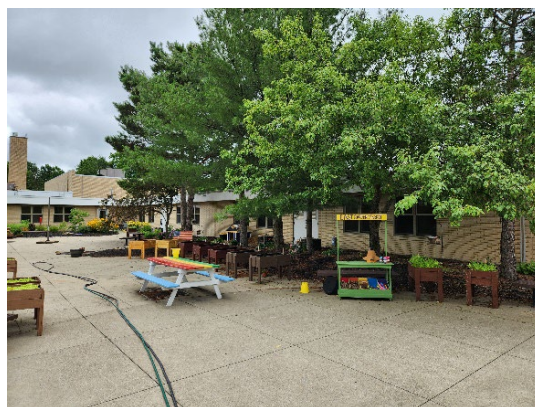
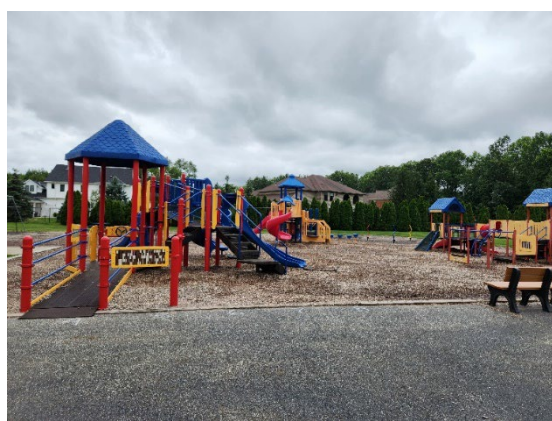
The playground equipment is primarily constructed of metal and high-density plastic, and is in fair condition. Playground equipment is placed to provide compliant fall zones, and on a non-compliant wood fiber mulch of insufficient depth. The hard surface play area is an asphalt surface with a basketball court and funnel ball. The playground area is equipped with minimal tables and benches in fair condition.

Provide for the resurfacing of all asphalt on the site due to condition. Provide for the replacement of concrete sidewalks and curbs as required. Provide for the replacement of the concrete dumpster pad due to condition. Provide for the replacement of playground equipment due to age. Provide for the replacement of playground soft-surface due to non-compliance. Provide for the replacement of fence gate due to damage.

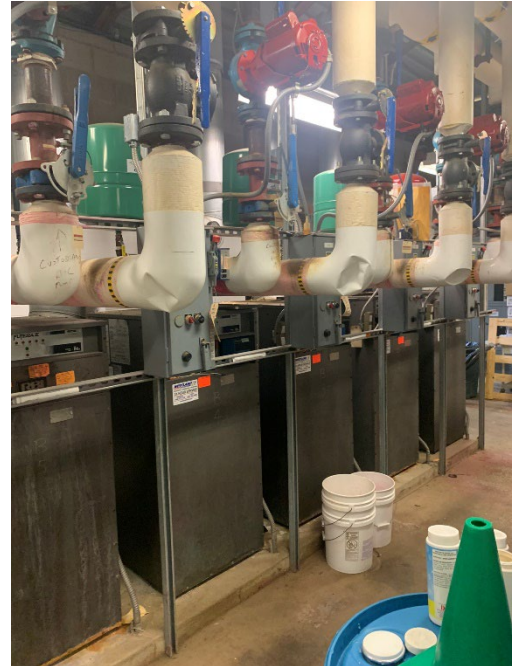
The entire facility was constructed in 2001 and split into a North half and South half. The North has 5 RBI boilers (1.5 million BTU) that are 22 years old and in poor shape. The South half has 3 Aerco boilers that although they appear to be in fair shape, the school personnel has not indicated any operational issues. Due to the age of these boilers, they are still approaching the end of their useful life. The boilers from both halves of the building provide heating hot water to cabinet unit heaters, unit heaters, convectors, air handling units, VAV for reheating coils and other miscellaneous type heating devices. All the classroom wings are served from air handling units that also have chilled water providing air conditioning throughout the facility. The classrooms utilize a plenum return system that does not utilize louvered doors or transfer grilles for relief air venting. The school district had noted in our walkthrough locations where the acoustical ceiling tile is curled up which may indicate the transfer grilles to the ceiling plenum aren't large enough. A review of the existing drawings along with totaling up the airflows can determine if the transfer grilles are adequately sized and located. The system does appear to provide proper amounts of ventilation air. There is no central energy recovery system. There are separate controls for each space. The temperature controls are electronic and appear to be adequate for their intended use.

Remove/Replace both boiler systems. 5 boilers in the North half and 3 boilers in the South half. Correct return air back to air handling units.

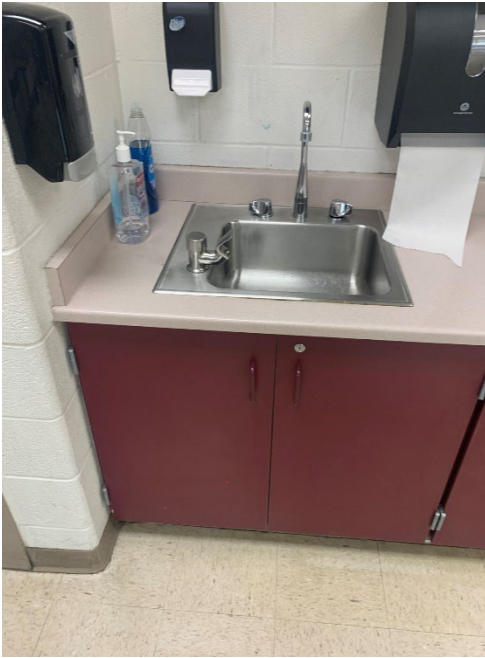
Classroom sink w/drinking fountain

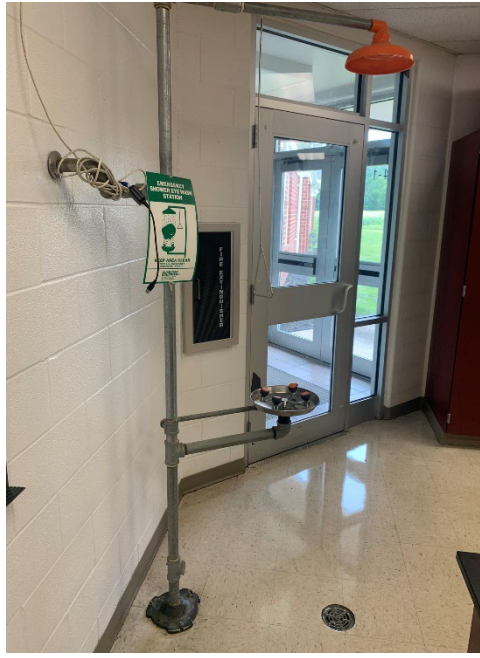
Eyewash

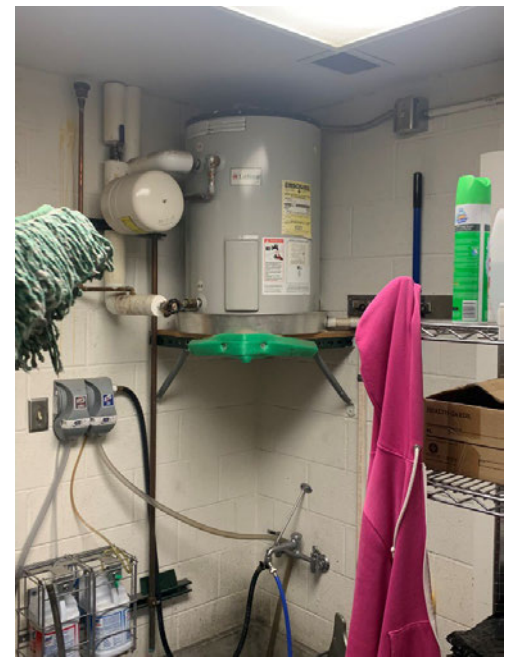
The 10-gallon electric water heaters, along with the 30-gallon heater appear to be 7-10 years old and although they are operating adequately, they are approaching the end of their useful life. The gas-fired domestic water boiler is original to the construction and is in poor shape and should be replaced.

10 Gallon electric water heater

Remove/Replace 7 electric water heaters.

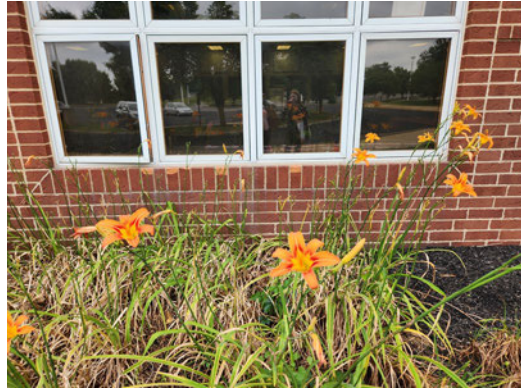
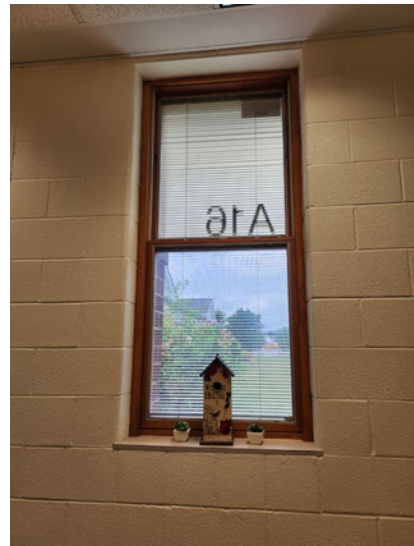
The overall facility is equipped with wood windows and aluminum cladding, which are original to the building installed in 2001, 2004, and 2006. The existing window system is combination of casement and double hung sashes. The windows have insulated glass with integral blinds and non-thermally separated wood framing. According to district personnel the windows are unable to close and do not lock. Window system hardware is in fair condition. This facility is not equipped with any curtain wall systems. This facility does not feature any glass block windows.

Provide a new insulated thermally broken window system with integral blinds to meet with Ohio School Design Manual requirements.

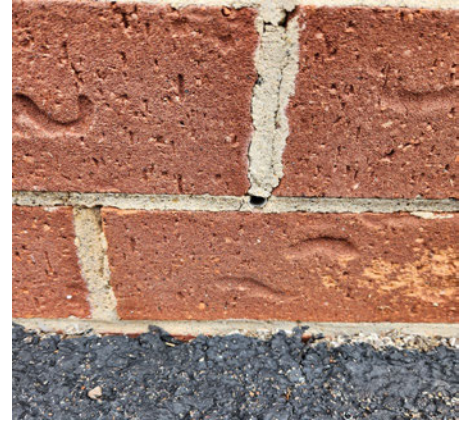
The exterior masonry has not yet been cleaned and sealed, showing evidence of mortar deterioration and brick cracking at window locations which needs to be addressed. Architectural exterior accent materials consist of EIFS, which is in fair condition.

Weep Holes

Provide tuckpointing in all areas of mortar deterioration as required through the overall facility. Provide masonry cleaning, sealing, and caulking as required through the overall facility. Prep and paint exposed steel lintels through the overall facility.

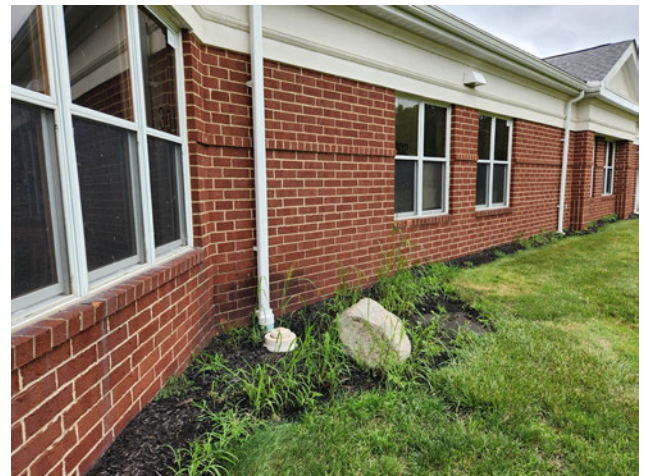
Exterior walls and downspout

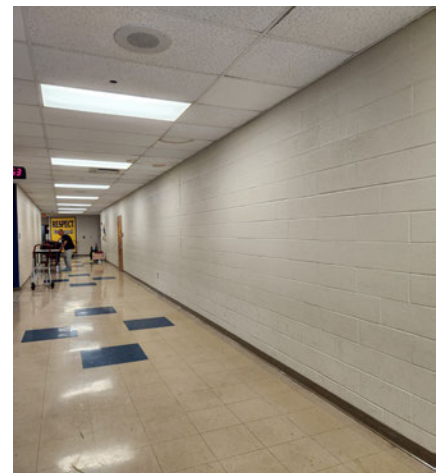
Hallway

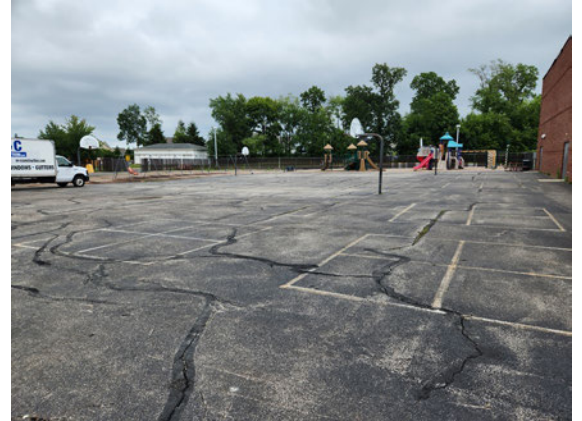
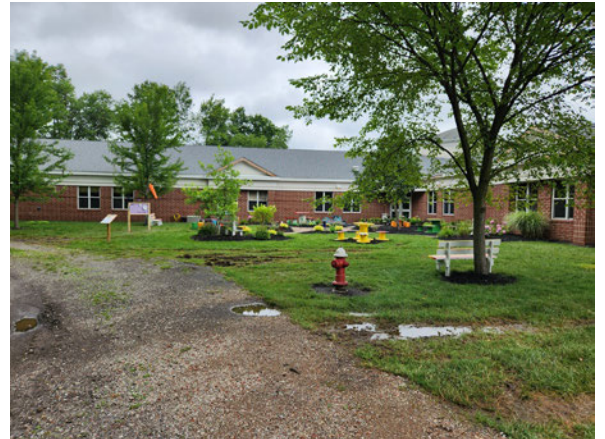
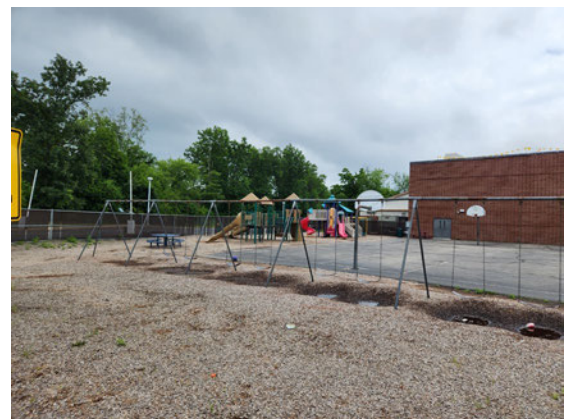
The playground equipment is primarily constructed of metal and high-density plastic, and is in fair condition. Playground equipment is placed to provide compliant fall zones, and on a non-compliant wood fiber mulch of insufficient depth. The hard surface play area is an asphalt surface with a basketball court. The playground area is equipped with minimal tables in fair condition.

Provide for the resurfacing of all asphalt on the site due to condition. Provide for the replacement of concrete sidewalks and curbs as required. Provide for the replacement of the concrete dumpster pad due to condition. Provide for the replacement of playground equipment due to age. Provide for the replacement of playground soft-surface due to non-compliance. Provide for the replacement of fence gate due to damage.

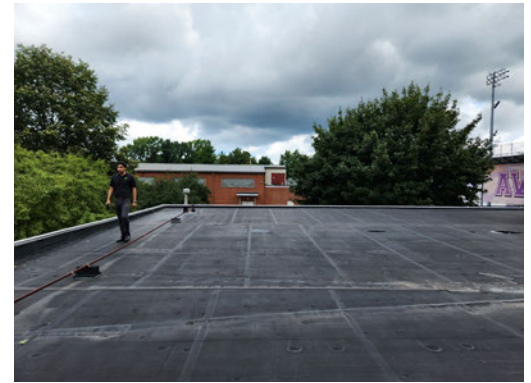
The roof over the overall facility is an EPDM system that was installed in 1994, and is in fair condition. Active leaking at a low roof to high roof location at the gymnasium and corridor wall was observed due to heavy rains the night before. The District has reported that this is common. Access to the roof was gained by an access hatch that is in fair condition. Fall safety protection cages are not required, and are not provided.

There were observations of standing water on the roof. Metal cap flashings are in fair condition. Roof storm drainage is addressed through a system of roof drains, which are properly located, and in fair condition. The roof is not equipped with overflow roof drains.

EPDM Roof

The roof over the overall facility requires replacement to meet Ohio School Design Manual guidelines for age of system. The flashing and coping on the overall facility require replacement due to condition. Due to existing conditions any deck that is wet and drains need to be replaced as well as adding overflow drains. Replace access hatch and ladder to roof.

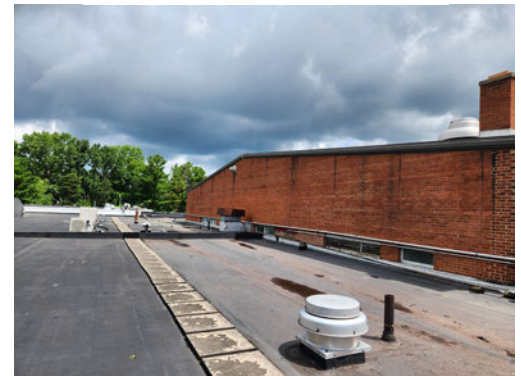
Roof Drains

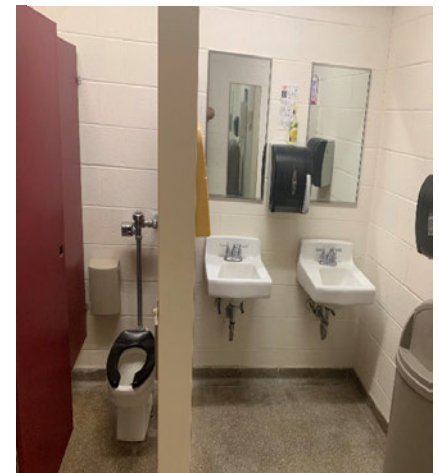
Wall-Hung Lavatories with Manual Faucets

- Remove/Replace 2 domestic water heaters.
- Remove/Replace all underground sanitary piping due to age.
- Remove/Replace all domestic water lines due to age and condition.
- Remove/Replace 15 water closets.
- Remove/Replace 4 urinals.
- Remove/Replace 14 lavatories.
- Remove/Replace 3 electric water coolers.

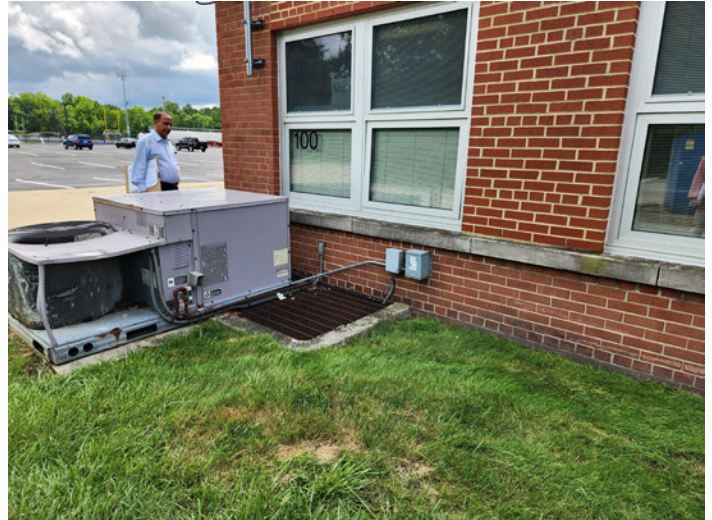
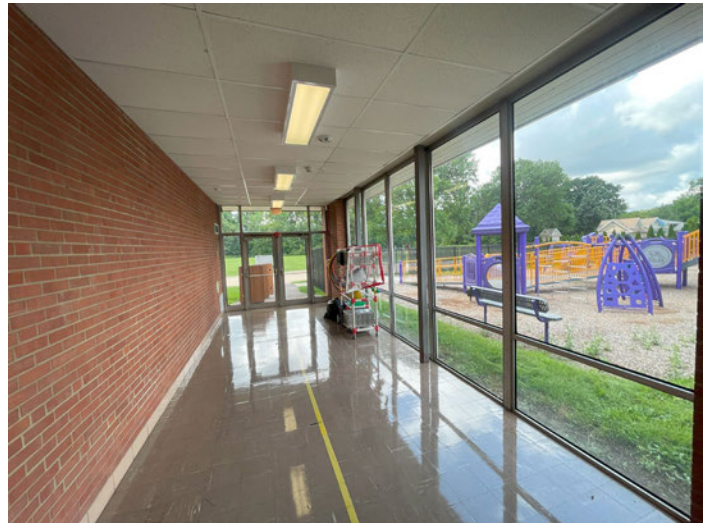
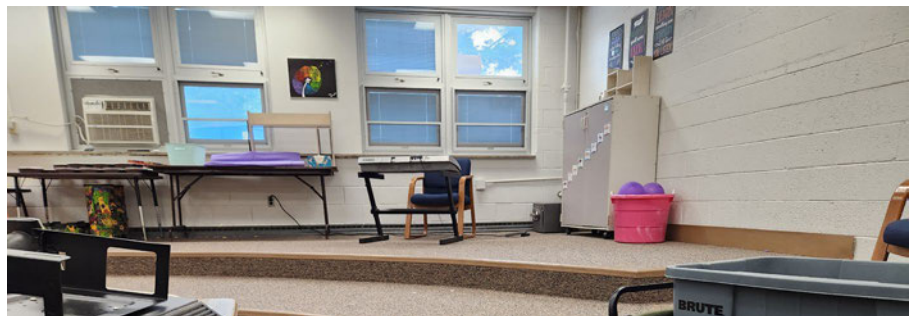
The overall facility is equipped with aluminum frame double pane glazed type window system, which was installed in 1994, and is in fair condition, but the window system does not have thermally broken separation as required by code. The window system features operable windows throughout the building, and are not equipped with opening limiters. Window system seals are in fair condition, with minimal air and water infiltration being experienced. Window system hardware is in fair condition. The window system features integral blinds, which are in fair condition. This facility is not equipped with any curtain wall systems. This facility does not feature any glass block windows.

The exterior doors in the overall facility are equipped with aluminum frame sidelights and transoms with double glazed insulated glazing, in fair condition. Exterior door vision panels are glazed insulated.

Replace all windows in the overall facility due to windows not being thermally broken as required by code.

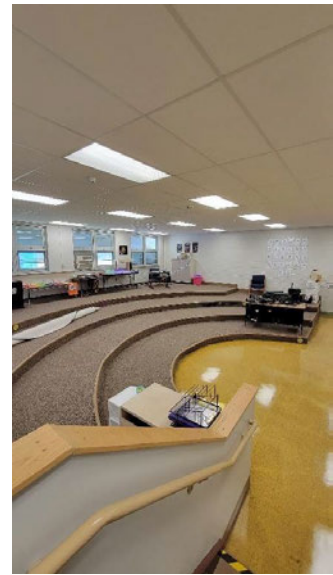
The typical Classrooms in the overall facility are equipped with T-8 2x4 lay-in fluorescent fixtures with dual level switching. Classroom fixtures are in good condition, providing an average illumination of 40 FC, which is less than the 50 FC recommended by the OSDM.

Typical Class Lighting

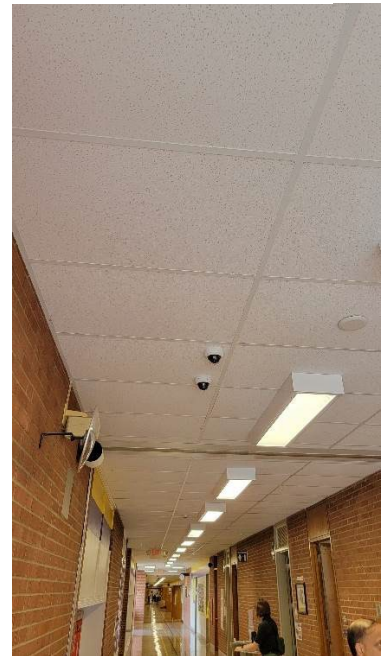
Typical Corridor Lighting

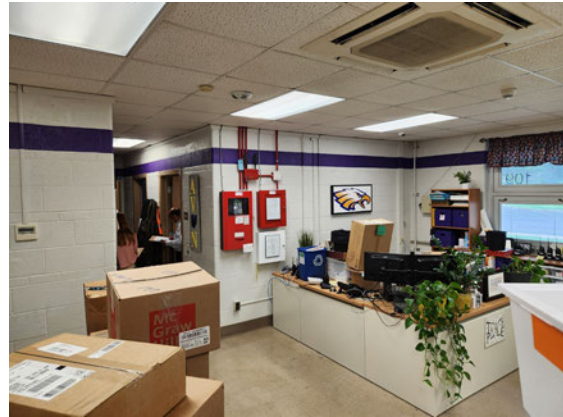
The overall facility is equipped with an addressable type fire alarm system installed in 2021, and in good condition, with voice communication, consisting of manual pull stations, horn/speaker indicating devices, and smoke detectors. The system is automatic and is monitored by a third party. The system is equipped with sufficient audible speaker / strobe indicating devices, and smoke detectors.

Fire Alarm Panel

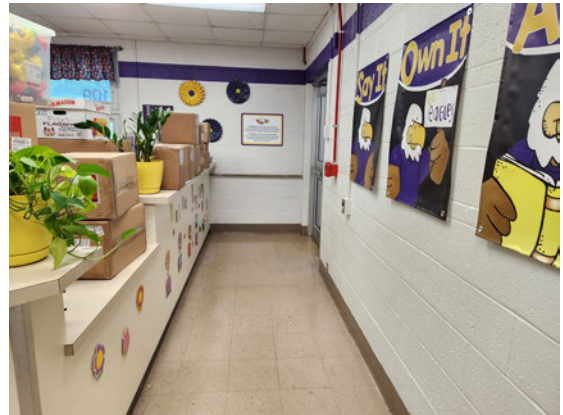
Fire Alarm in Office

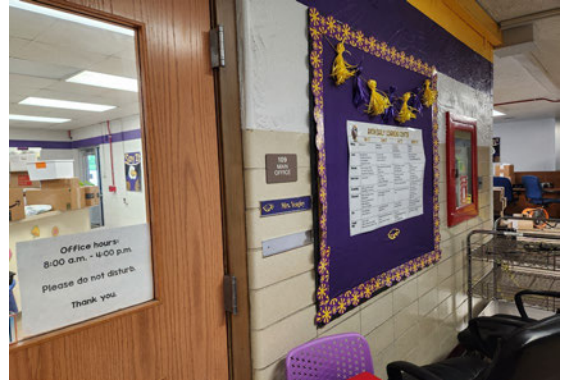
ADA Signage

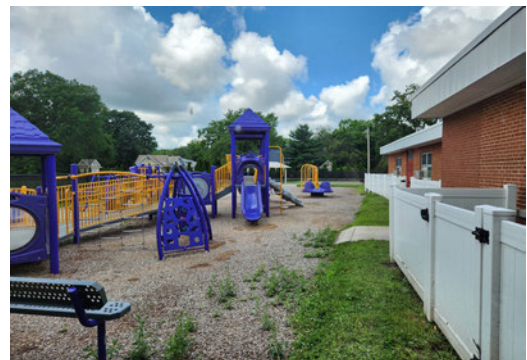
Exterior doors are equipped with ADA hardware. Building entrances should be equipped with 1 ADA power assist doors, and none are provided. Playground layout and equipping are not compliant due to playground surface being wood chips and no accessible mats present.

Playground

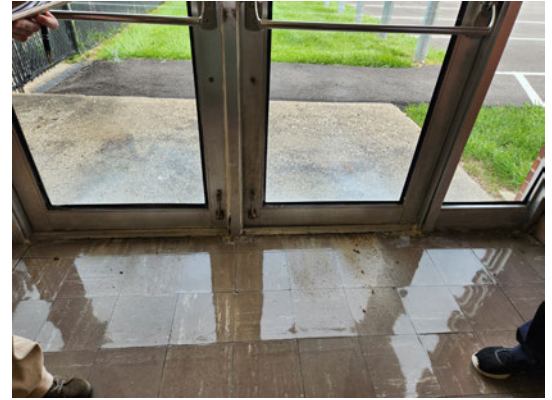
Exterior Door

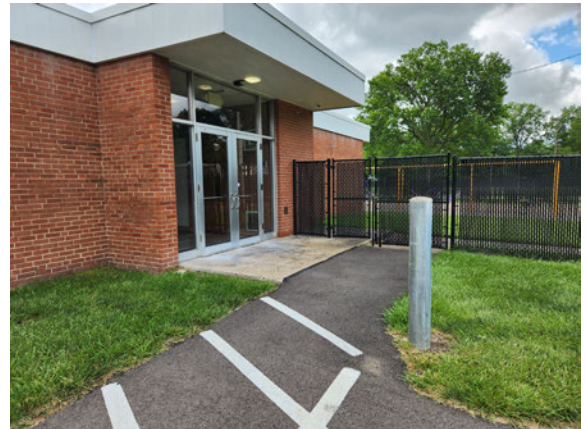
Exterior Door

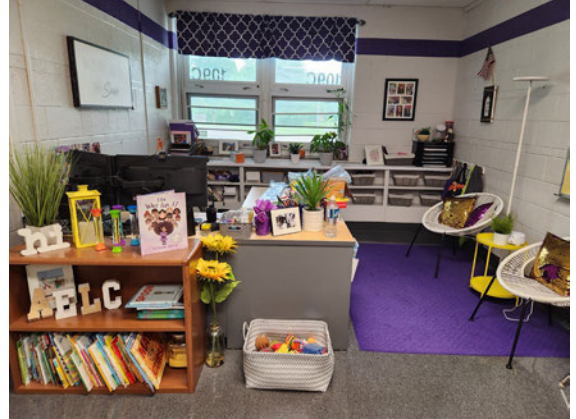
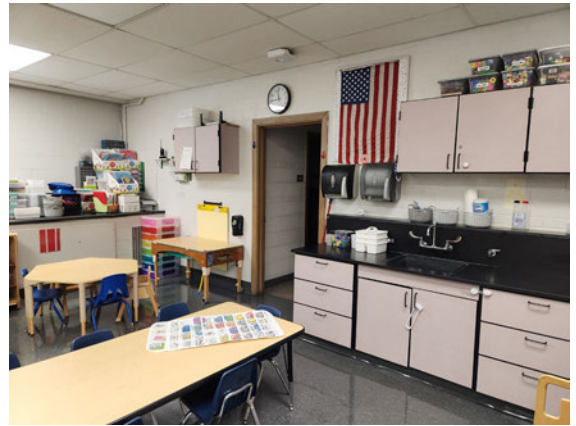
The typical Classroom furniture is of consistent design, and in generally fair condition, consisting of student desks & chairs, teacher desks & chairs, desk height file cabinets, reading tables, computer workstations, bookcases, wastebaskets, etc. The facility's furniture and loose equipment were evaluated, and on a scale of 1 to 10 the overall facility received a rating of 4 due to observed conditions, and due to the fact that it lacks some of the Design Manual required elements.

Provide for replacement of outdated or inadequate furnishings.

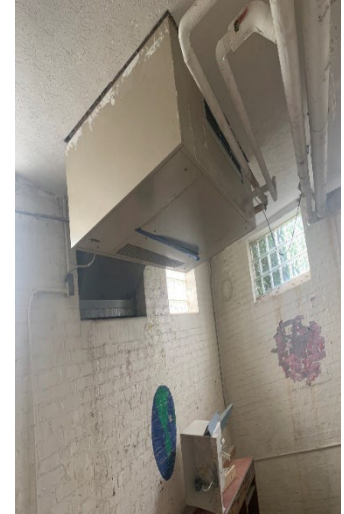
The original building was built in 1927 with the addition occurring in 1970. The heating for the entire facility occurs from 2 gas-fired, hot water boilers that appear to be over 30 years old. These boilers provide heating hot water to cabinet unit heaters, unit heaters, unit ventilators, connectors, radiators, multizone air handling units, and other miscellaneous type heating devices. The 1970 addition utilizes packaged terminal heating and air conditioning units. The interior office and workspace area of this addition was renovated in 2015. This space has ducted fan coil units that have hot water heating coils and DX cooling coils with condensing units located on the roof. None of the systems appear to provide adequate ventilation to meet codes. In addition, all the heating equipment and terminal devices are at the end of their life expectancy and should be replaced.

Unit Ventilator
Ceiling Mounted

Provide overall new heating systems that will also include a central air conditioning system. Provide funding for upgrading the non-ducted system to a ducted system throughout the facility.

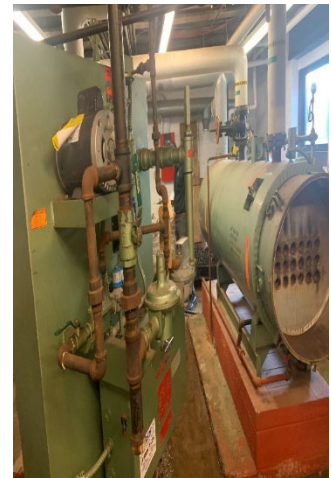
Hot Water Boilers

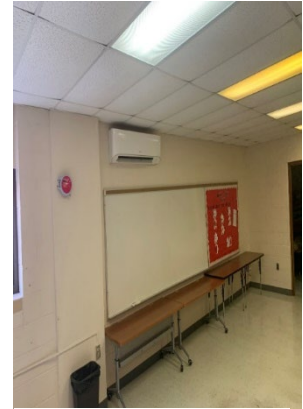
Areas of the 1927 original building have portable air conditioning units along with mini split units and through the wall AC units. None of these units have ventilation capabilities or are viable for a board office application. The 1970 addition utilizes package terminal units and an outdoor condensing unit. General toilet exhaust is present and working in all restrooms, janitor's closets and storage areas.

Mini Split A/C Unit

Update entire system as noted in Item A- Heating.

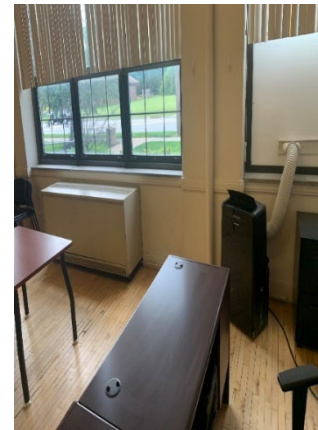
Portable A/C Unit

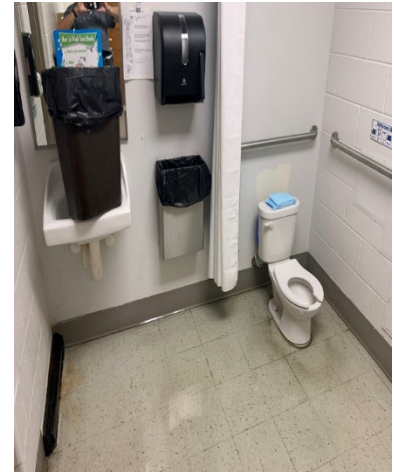
There is one locker room for girls and one for boys. These contain 2 wall-hung lavatories and 17 showers. There are 3 staff restrooms that contain 4 wall hung water closets (2 with manual flush valves and 2 with automatic flush valves) and 4 countertop lavatories with manual faucets. There is 1 special education classroom that contains 1 floor mount, tank-type water closet, 1 wall-hung lavatory with manual faucet and 1 shower.

With the age of the fixtures, all of the fixtures should be replaced with low flow type.

Special Education Rest Room

- Remove/Replace domestic hot water boiler system.
- Remove/Replace all underground sanitary piping.
- Remove/Replace all water lines due to age and condition.
- Remove/Replace 26 water closets.
- Remove/Replace 15 urinals.
- Remove/Replace 29 lavatories.
- Remove/Replace 2 electric water coolers.
- Add 25 classroom sink and bubbler drinking fountains.

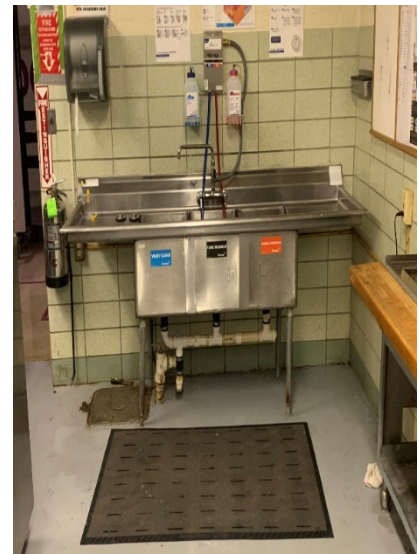
(3) Compartment Sink w/Grease Trap

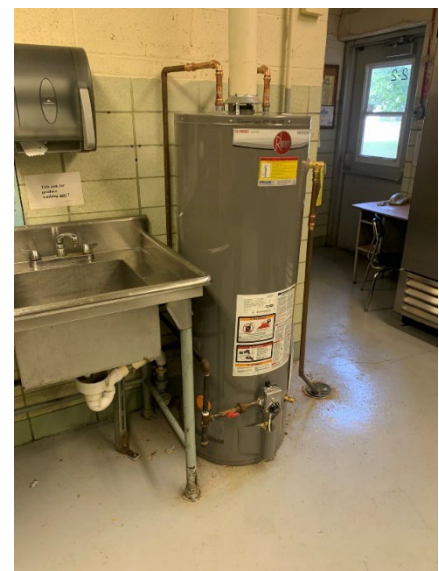
Kitchen Hot Water Heater

The kitchen has the required staff restroom (counted above) and the following kitchen fixtures: 3 bowl sink, single bowl sink, in-floor grease trap, and a kitchen domestic water heater (50-gallon) that appears to be about 5 years old and in fair shape.

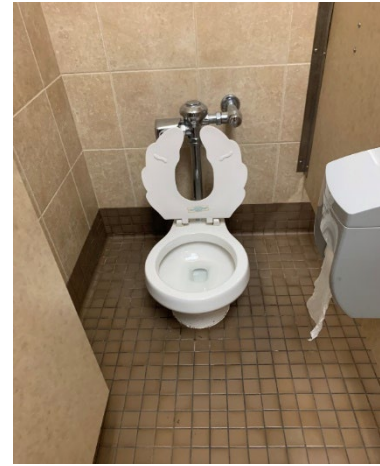
PK Group Restroom

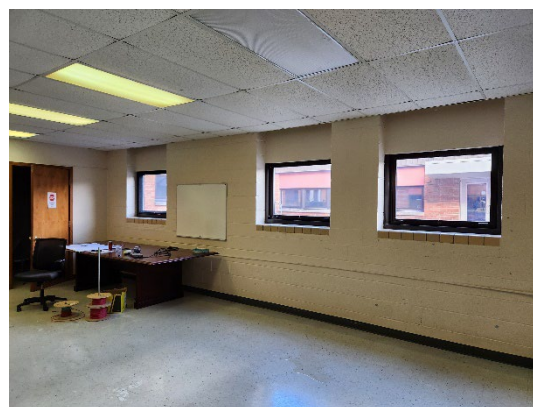
The 1957 Addition is equipped with thermally broken aluminum frame windows with double glazed insulated glazing type window system, which was installed in 2015, and is in fair condition. The window system features operable windows throughout the addition, and operable windows are equipped with opening limiters in fair condition and insect screens are not present. Window system seals are in good condition, with no air and water infiltration being experienced. Window system hardware is in good condition. The window system features surface mounted blinds, which are in fair condition.

First Floor Windows

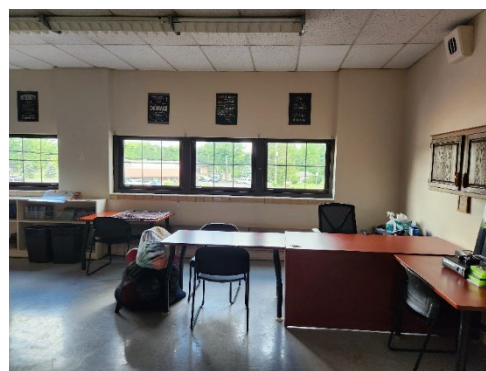
The 1929, 1949, and 1950 Additions are equipped with non-thermally broken aluminum frame windows with double pane glazing type window system, whose installation date is unknown but is not original to the building, and is in fair condition. The window system features operable windows in most of the building, and operable windows are equipped with opening limiters but no insect screens are present. Window seals are in fair condition with no air and water infiltration being experienced. Window system hardware is in poor condition. The window system features surface mounted blinds where blinds are present. Not all rooms or windows feature blinds.

Second Floor Windows

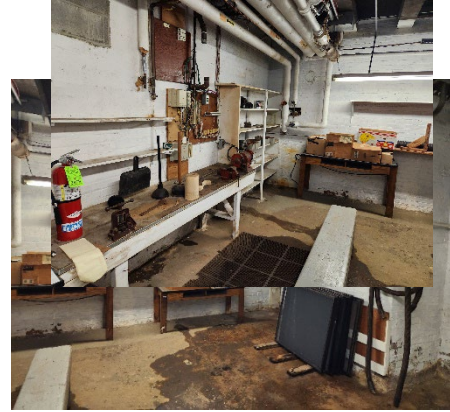
The overall facility is equipped with concrete masonry unit foundation walls on concrete footings, which displayed no locations of significant differential settlement, or cracking, and are in fair condition. No significant issues related to foundation cracking or spalling were encountered. The District reports that there has been past leaking at the northern side of the 2015 renovations as well as the southern side of the 1957 Addition. The exterior grading between additions, specifically between the 1957 Addition and the 1950 Addition slopes towards the buildings. This grading, as well as an undersized catch basin, leads to water infiltration at the building during large rain events. The day of the assessment showed water infiltration at the main floor level, as well as water infiltration below grade in the main electrical room.

Provide membrane waterproofing system and drainage throughout the lower level.
Provide drainage tile system as indicated in the description above as having flooded.
Additional water control to be provided for in Item P.

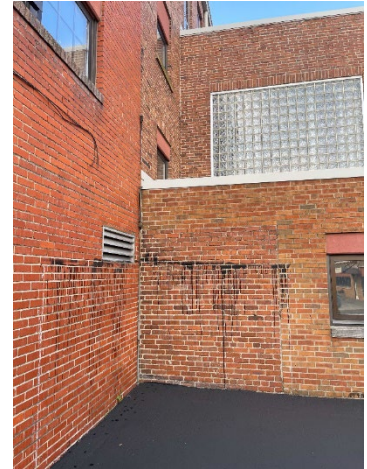
The overall facility has a brick veneer on load bearing masonry wall system, which displayed locations of deterioration, and is in generally poor condition. Control joints are not provided at lintel locations, at doors and windows, building corners, and wall offsets though most areas do not indicate that this would be needed. The school does not contain expansion joints and none are needed, as there is no indication of exterior masonry cracking or separation at appropriate locations. There was one location of major exterior wall cracking in the south east corner to the 3 story portion of the 1929 addition. No interior evidence of this cracking was found due to built-in casework at that location. Structural investigation is needed to determine the cause and extent of this cracking.

Exterior Walls of Building

Provide tuckpointing in all areas of mortar deterioration as required through the overall facility.

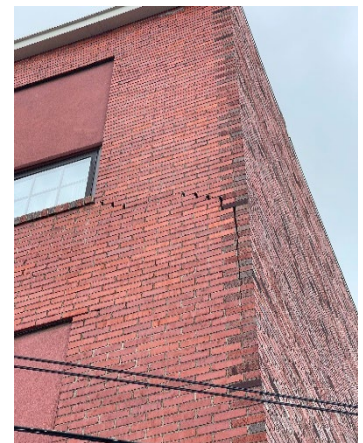
Cracking in Brick Exterior

Provide for structural investigation at the cracking location discussed above.

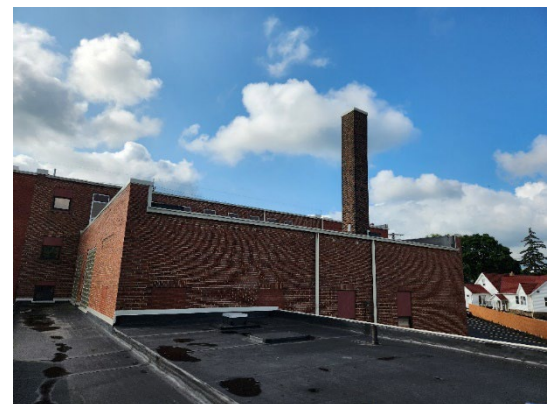
The window sills are brick or stone, and are in mostly poor condition. The exterior lintels are steel, and are rusting in most locations. Chimneys are in poor condition requiring much tuckpointing and possibly partial rebuilding if the HVAC system were to remain as is. *Chimneys will not be needed with the new HVAC system proposed in Item A and therefore should be removed.* Canopies over entrances are metal panel type construction, and are in fair condition. Exterior soffits are of cement plaster type construction, and in fair to poor condition, requiring cleaning and re-painting.

Roof and Chimney

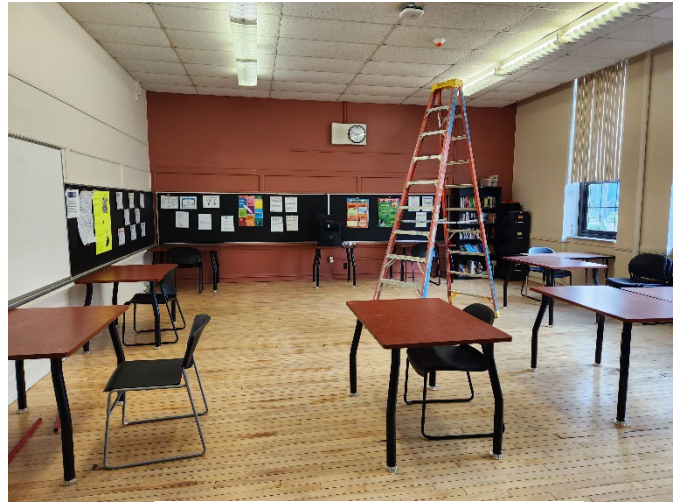
The overall facility features conventionally partitioned Classrooms with VCT or wood type flooring, lay-in ACT or plaster type ceilings, as well as plaster or wood paneling and plaster type wall finishes, and they are in poor condition. The overall facility has Corridors with VCT and terrazzo and plaster type wall finishes, and they are in fair to poor condition. The overall facility has Restrooms with tile type flooring, lay-in ACT type ceilings, as well as tile and plaster type wall finishes, and they are in fair to poor condition. Toilet partitions are composite, and are in fair to poor condition.

Classroom Original Building

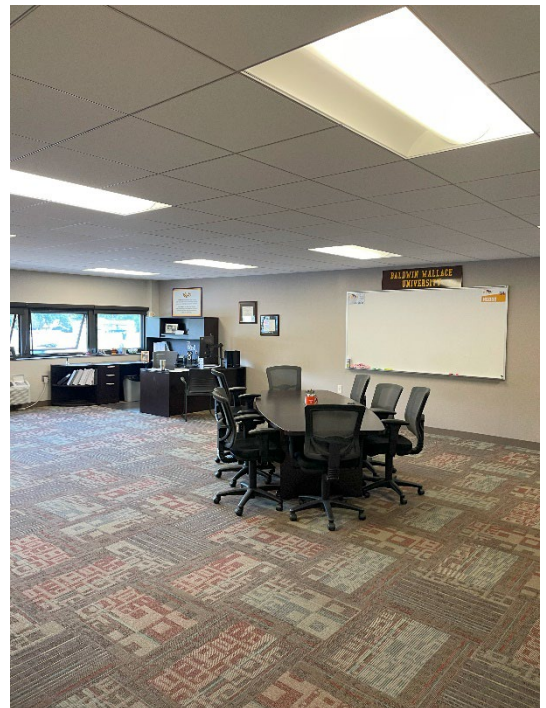
The Board of Education features offices with carpet type flooring, lay-in ACT type ceilings, as well as gypsum board type wall finishes, and they are in good condition. The BOE has Corridors with carpet and VCT type flooring, lay-in ACT type ceilings, as well as gypsum board and CMU type wall finishes, and they are in good condition. The BOE has restrooms with tile type flooring, lay-in ACT ceilings, as well as tile type wall finishes, and they are in good condition.

Office in New Addition

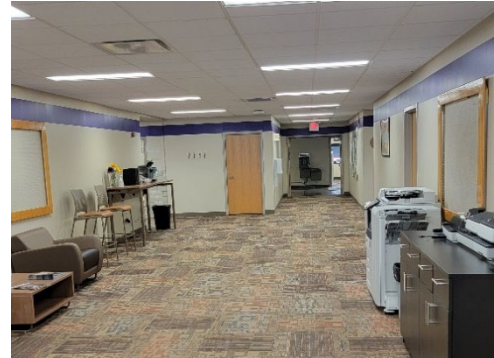
The typical Administrative spaces the overall facility are equipped with 2x4 T-8 fluorescent fixture type lighting in good condition, providing inadequate illumination based on OSDM requirements.

Typical Admin. Lighting in 1970 Addition

Provide complete replacement of lighting system due to condition and light levels, and installation of systems outlined in Item A.

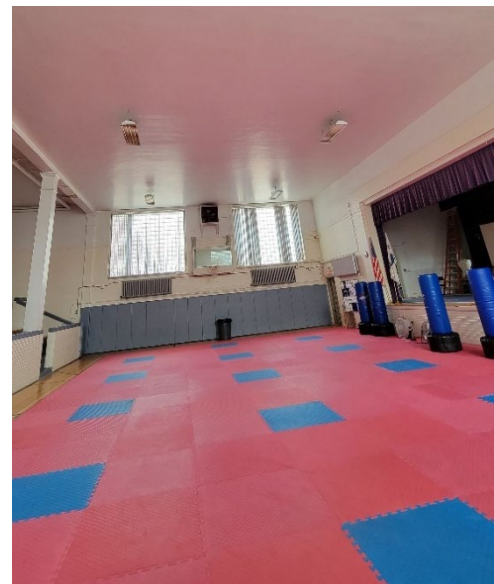
Gymnasium Lighting

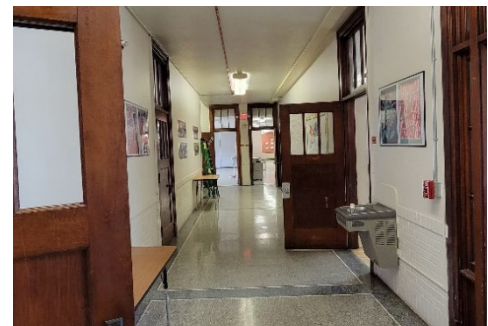
Typical Corridor Lighting in 1927 Original Construction

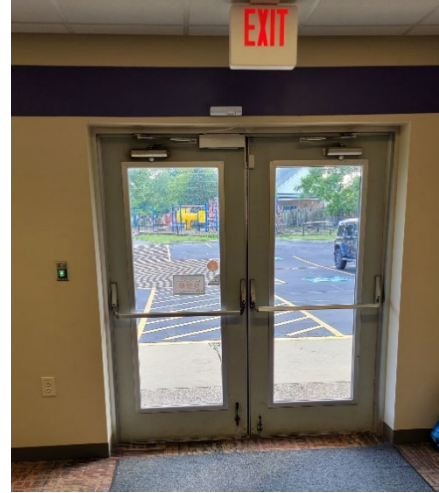
Exit Sign in 1970 Addition

Provide complete replacement of emergency / egress lighting system to meet Ohio School Design Manual and Ohio Building Code guidelines, and due to installation of systems outlined in Items A and K.

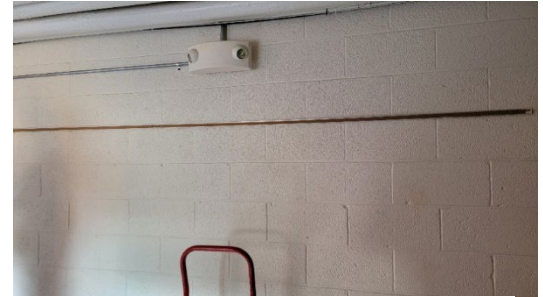
Emergency Egress Lighting in 1927 Original Construction

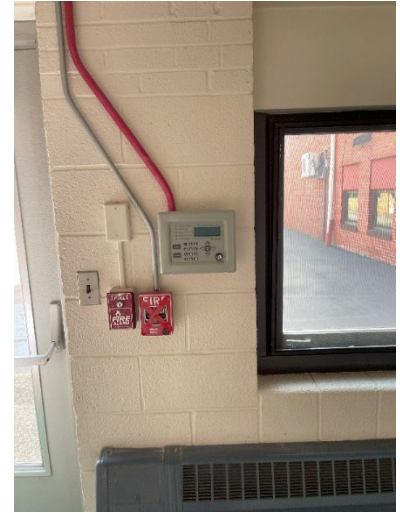
The overall facility is equipped with a Silent Knight model 6808 addressable type fire alarm system, installed in 2023, and in excellent condition, consisting of manual pull stations, horn and voice indicating devices, heat detectors, carbon monoxide detector, smoke detectors, and annunciator panels. The system is not equipped with any flow switches or tamper switches as there is no fire suppression system, but has capacity to support future fire suppression system. The system is adequately provided throughout, and does have additional zone capabilities. The system is fully compliant with Ohio building Code, NFPA, and Ohio School Design Manual requirements.

Fire Alarm next to Exit Door

Existing conditions require no renovation or replacement at the present time.

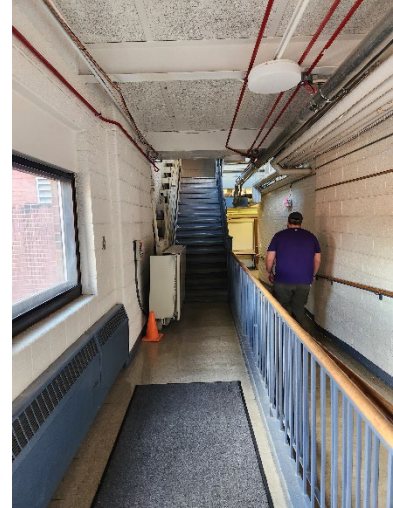
Stairwell in middle of Facility

On the interior of the building, space allowances and reach ranges are not compliant. There is not an accessible route through the building which does include protruding objects. Ground and floor surfaces are not compliant. Ramps and stairs do not meet all ADA requirements.

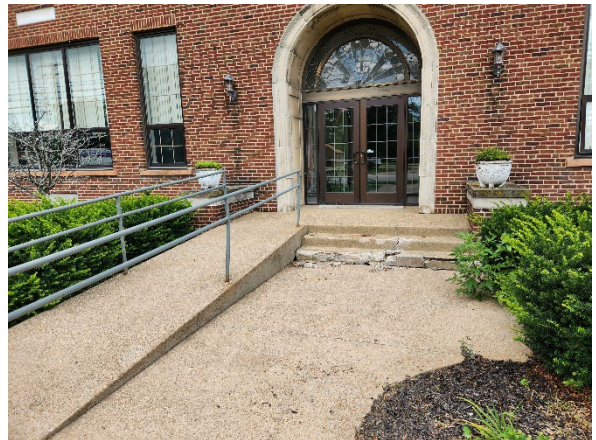
Main Entrance of Old Building

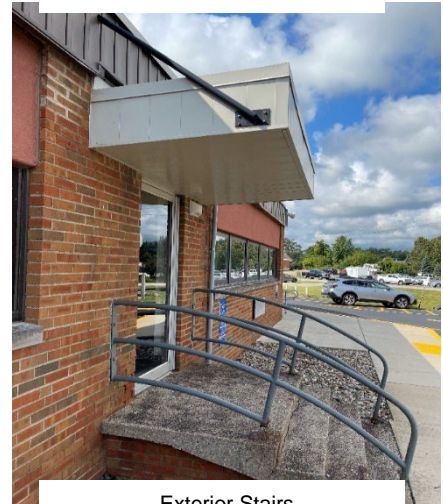
Exterior Stairs

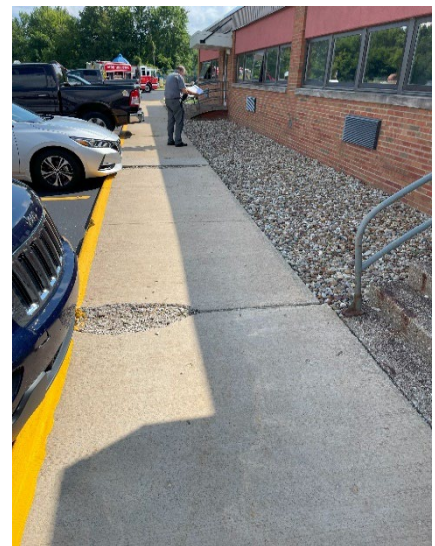
Sidewalk
