AVON LOCAL SCHOOLS FACILITY ASSESSMENTS

October 31, 2023

Executive Summary

FACILITY ASSESSMENT REPORT

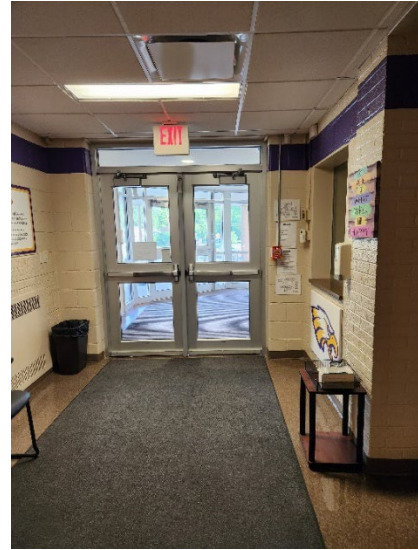
Exterior Exit Door in New Addition

Replace exterior doors in the overall facility, due to poor condition.

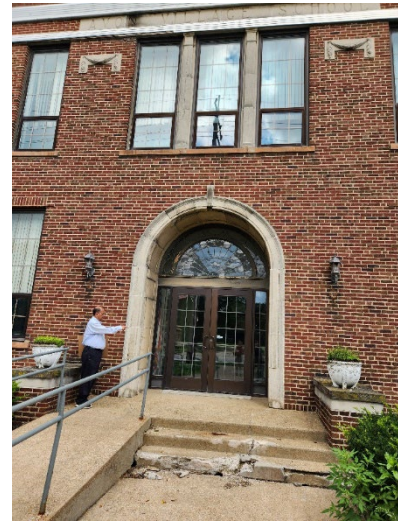
Entrance at Old Building
